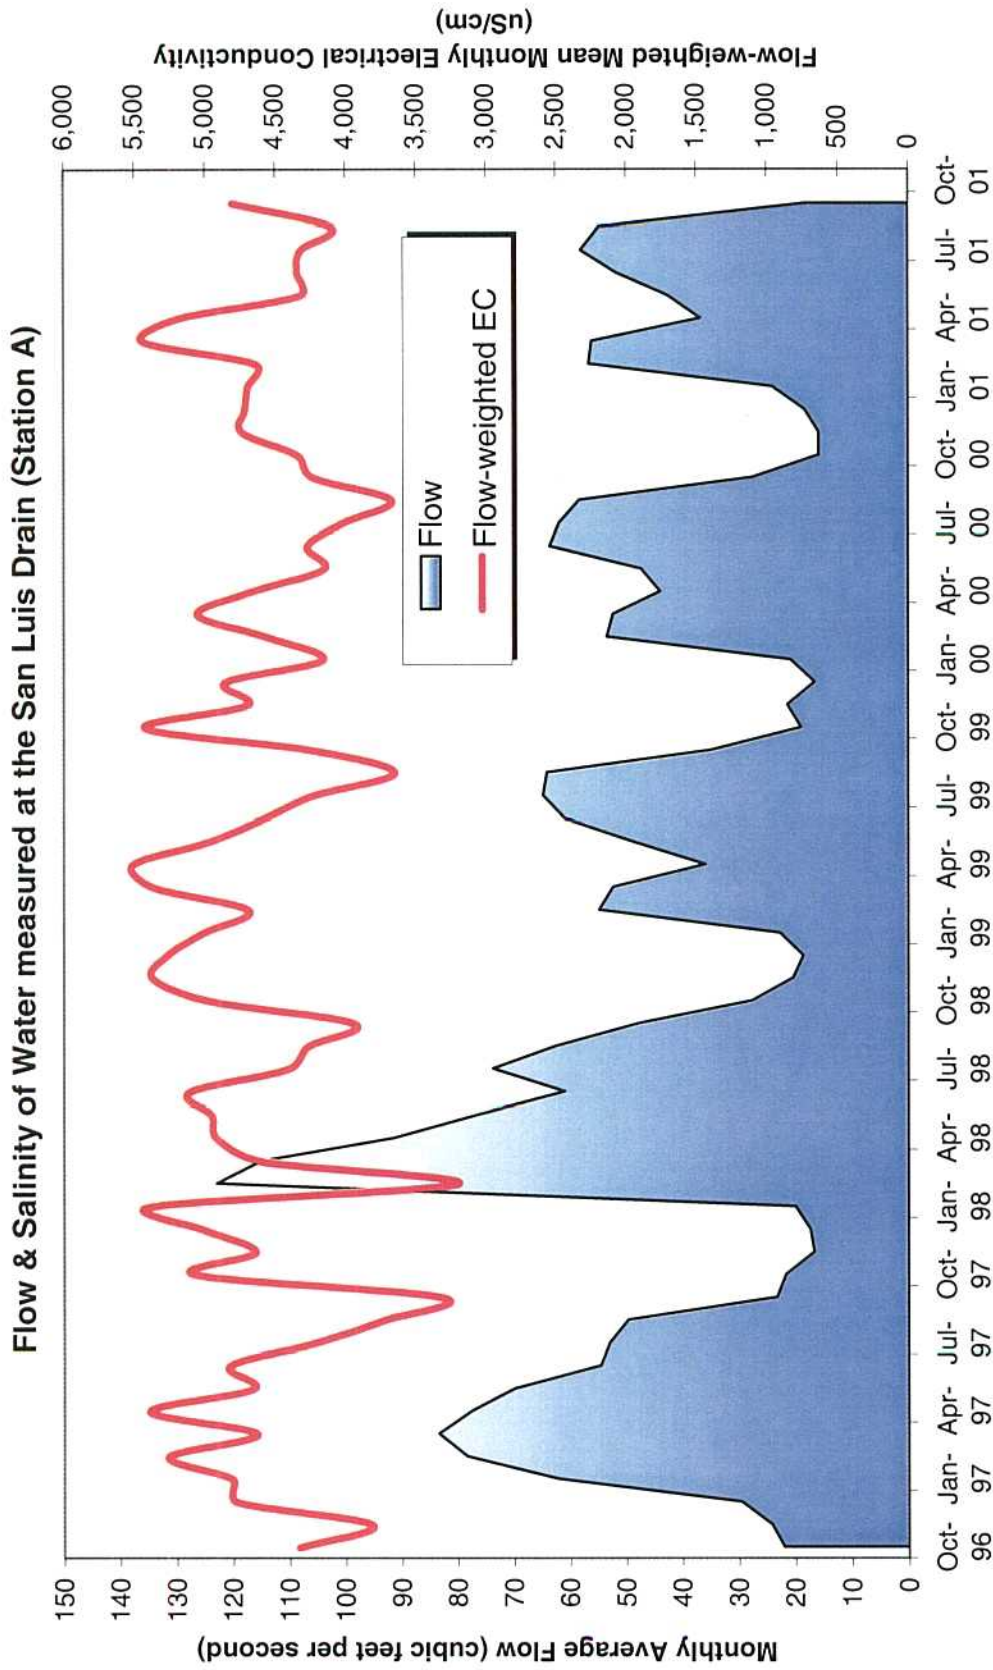
Figure 6. Comparison of flow and EC of water entering the San Luis Drain at Site A from the Grasslands watershed during 2001 with prior years. Source : USBR 2001.
