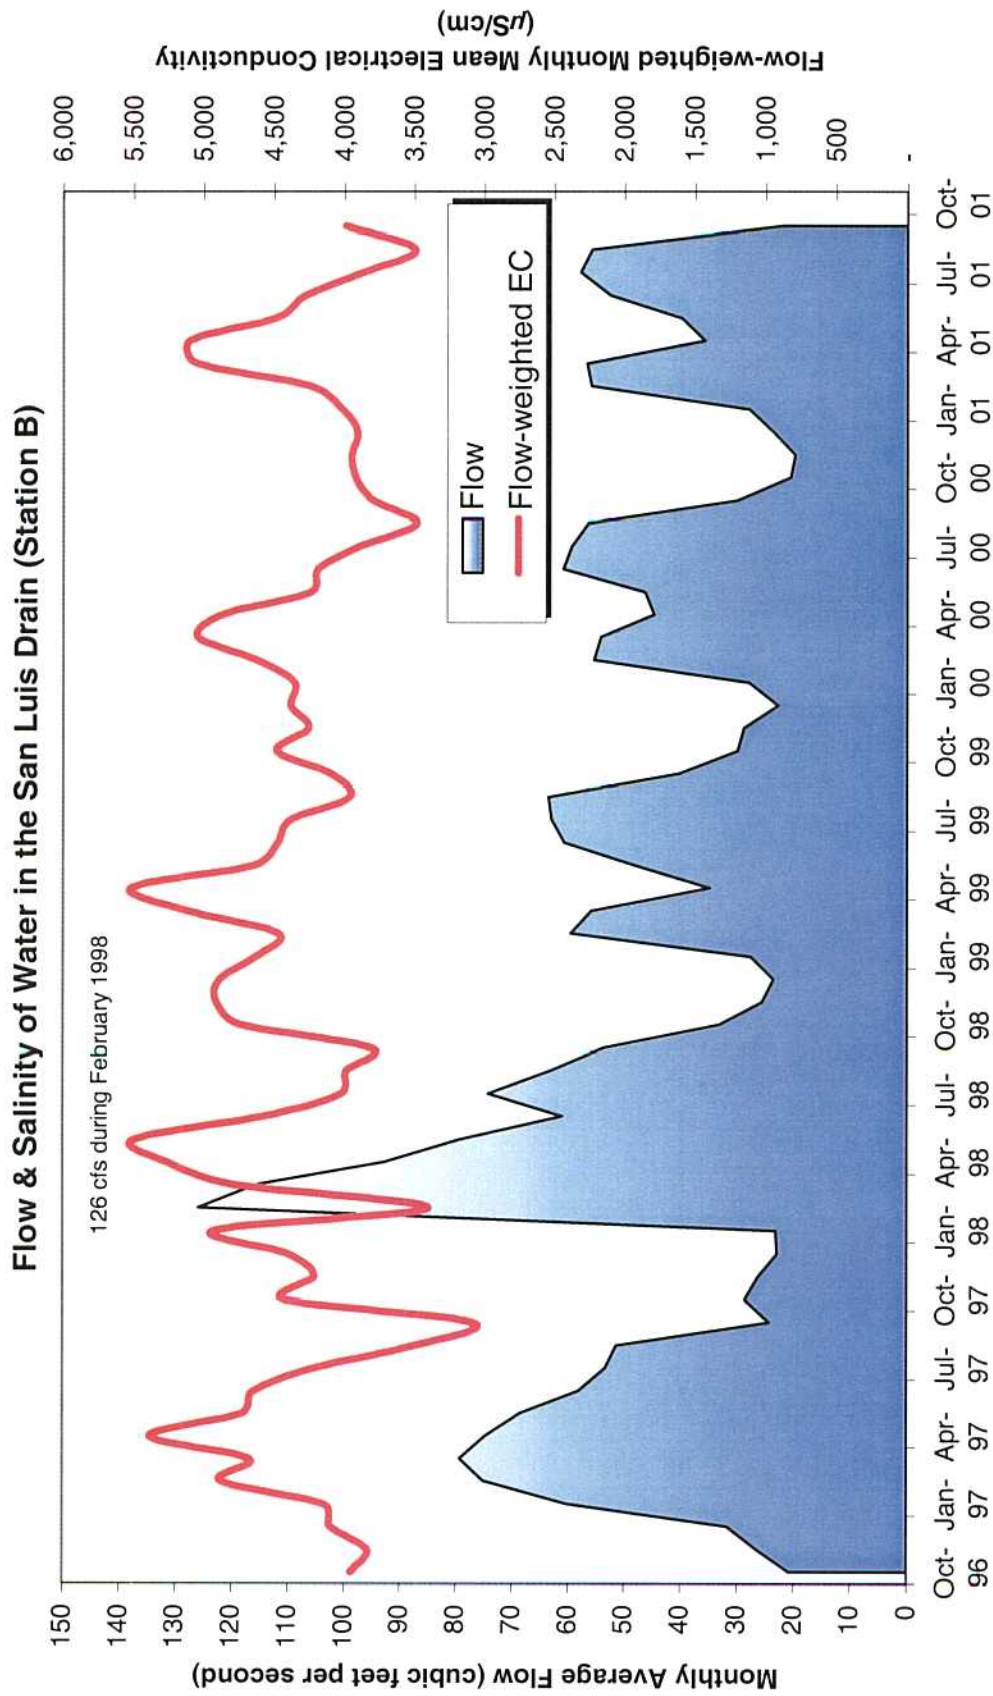
Figure 7. Comparison of flow and flow-weighted EC in the San Luis Drain at Site B immediately upstream of discharge point into Mud Slough during 2001 with prior years. Source ; USBR, 2001
