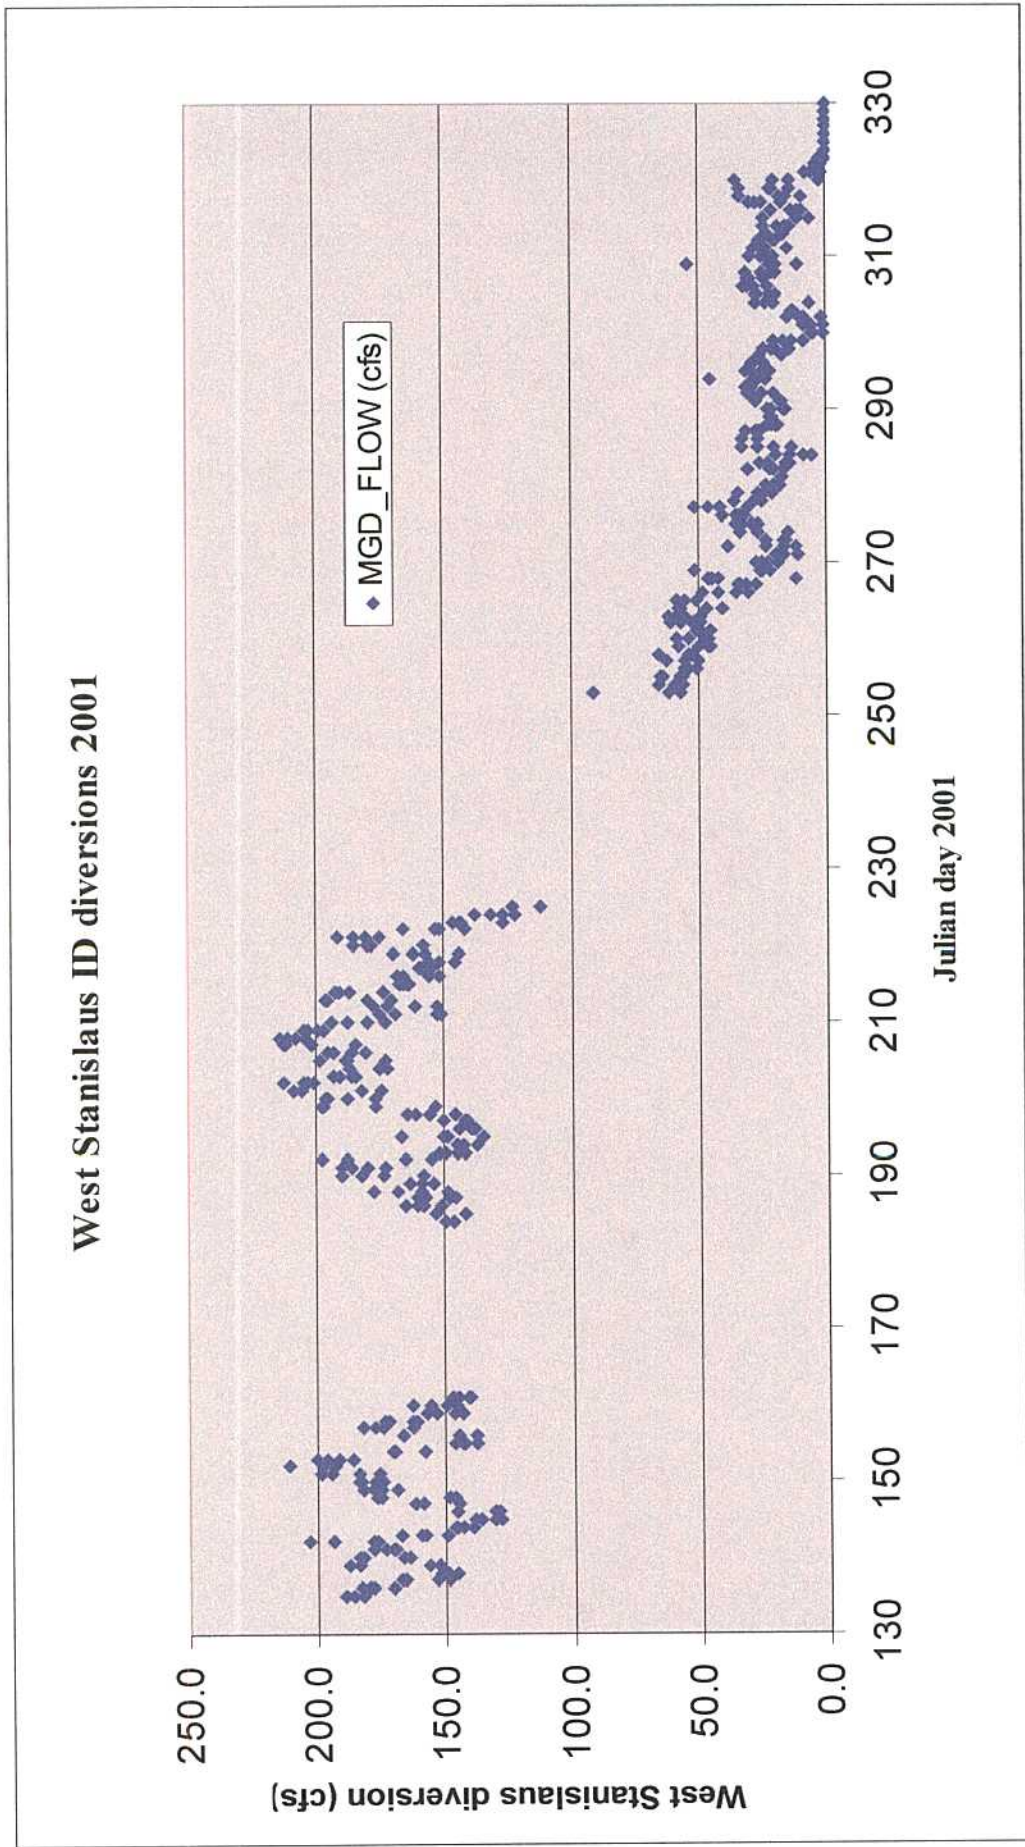
Figure 22 . Measured surface water diversions from the West Stanislaus ID monitoring station.
